APPENDIX A

IMPLICATIONS OF RECENT SEISMIC HAZARD STUDIES AT LANL

Larry Goen

**Engineering Science & Applications Division (ESA-EA)
Engineering Analysis Group
Los Alamos National Laboratory
Los Alamos, New Mexico**

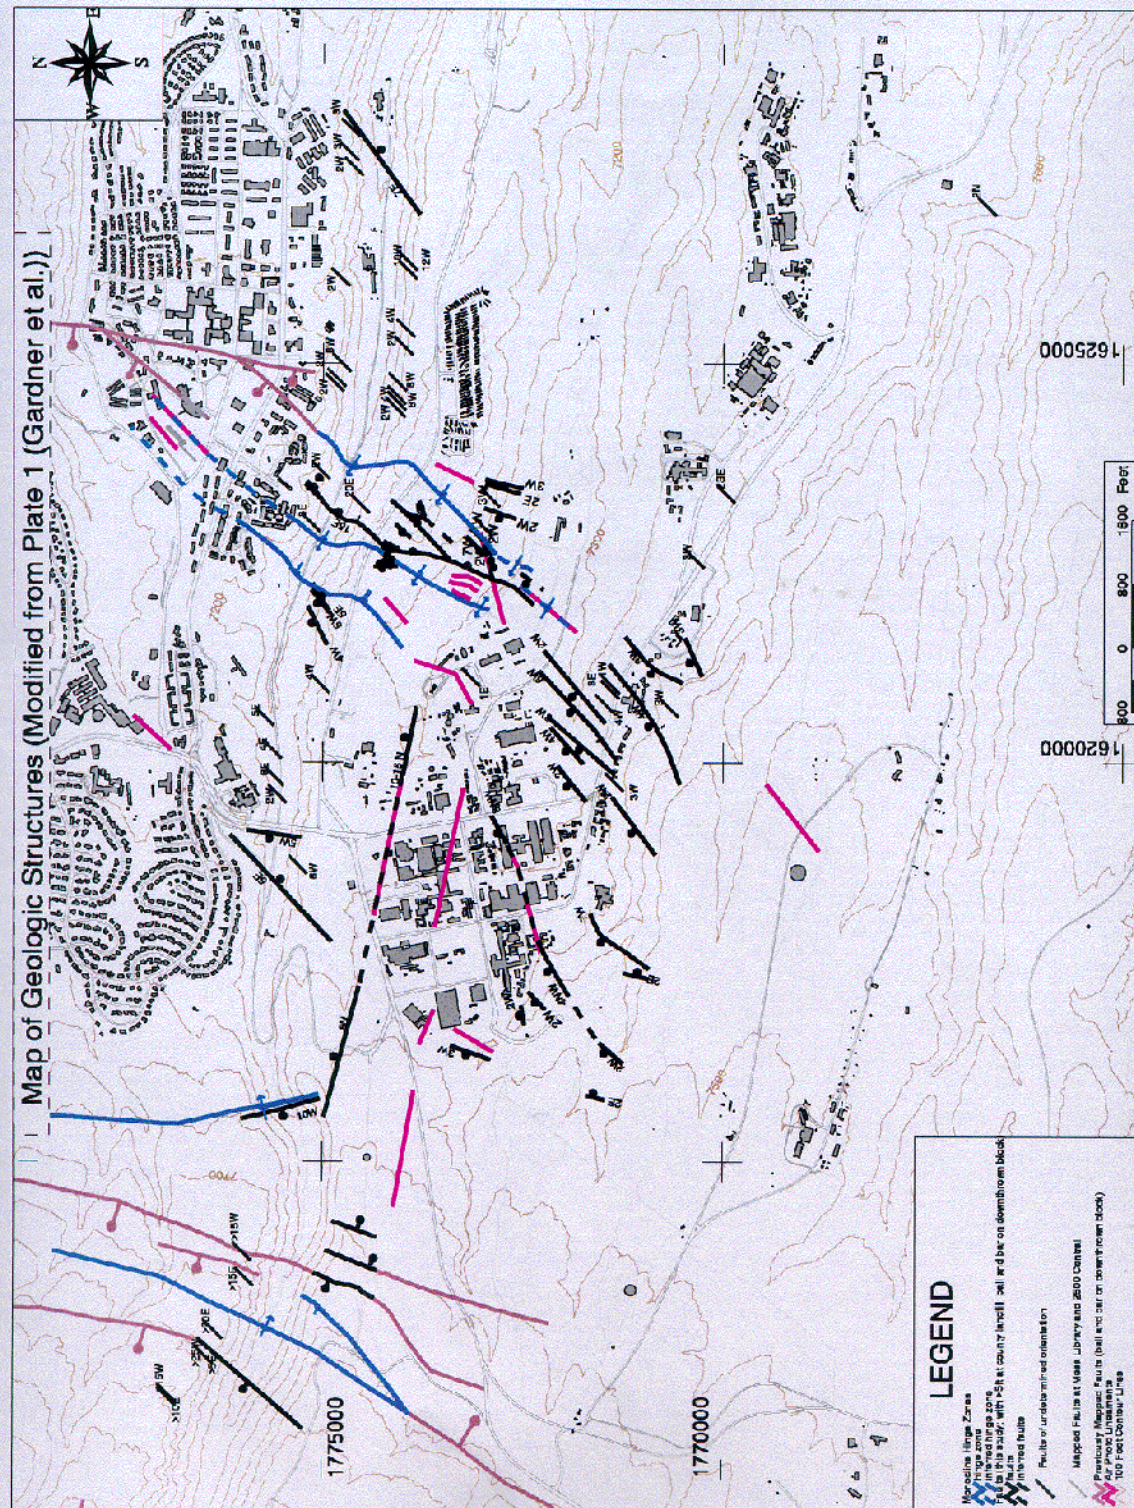
Figure 2 depicts the location faults found from TA-55 to TA-3 along with linear features found in the examination of air photos dating to the 1940's. The majority of the faults found lie in the eastern portion of TA-3, trending toward the southwest. The faults form a zone of vertical deformation which appears to be defining the southern end of the Rendija Canyon fault.

The fault zone increases in width as it progresses southward from approximately 2,000 feet at Los Alamos Canyon at the northern edge of the study to approximately 5,000 feet at Twomile Canyon at the southern edge of the study. The net vertical displacement across the zone as well as the amount of vertical displacement across individual faults gets smaller as the faults extend to the southwest. The net displacements decrease from approximately 100 feet at Los Alamos Canyon to less than 30 feet at Twomile Canyon with individual faults being less than about 10 feet. All of the displacements on these faults occurred over the last 1.22 million years.

The linear features from air photos could indicate linear features such as fences trails and roads but could also indicate the location of faults. These linear features were initially used as guides in the data gathering and analysis portions of this study. As can be seen in the figure, some of the lineaments do coincide with faults found in conjunction with this study, while others are located where no evidence for faulting has been found. It should be noted that the one air photo lineament trending to the northwest through the middle of TA-3 has been identified as a fault on the construction drawings for Buildings TA-3-42 and TA-3-200 but could not be verified in this study.

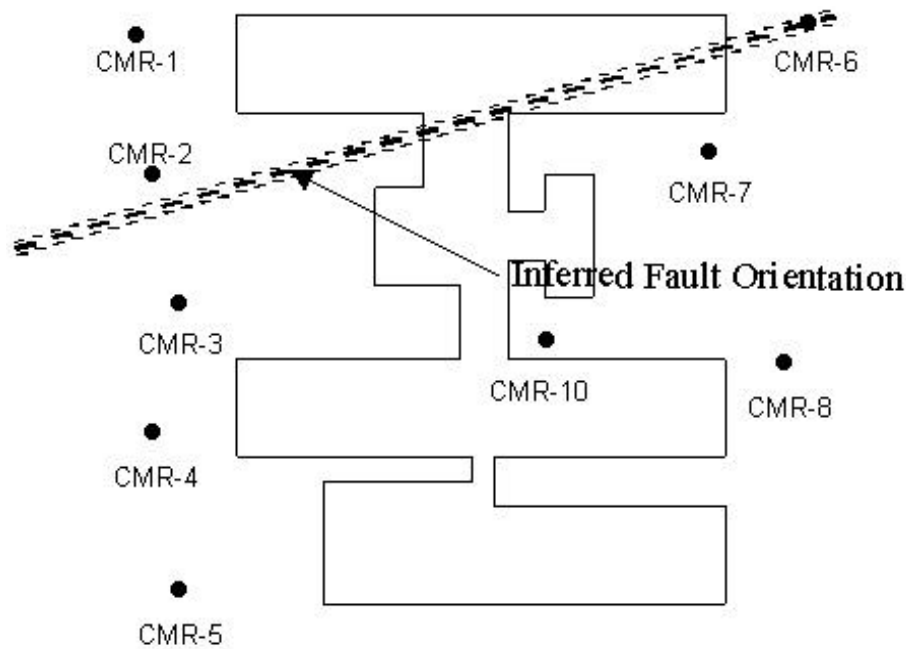
Figure 3 – Plan View of CMR Building with Inferred Location of Fault

The stratigraphic survey for TA-3 (Ref. 13) found faults with vertical displacements in the range of 1-10 feet in 1.22 million year old Bandelier tuff in the TA-3 area. The heaviest concentration of these faults is in the southeast corner of TA-3. This concentration is believed to be defining the southern end of the Rendija Canyon fault. The faults found include one under the Chemistry and Metallurgical Research (CMR) Building (Ref. 4) with a vertical offset of approximately 8 feet.

Analysis (Ref. 4) of the data obtained indicates that a fault is present at the CMR Building. Its location and inferred orientation are shown in Figure 3. The fault is contained within the core obtained from the CMR-6 and can be inferred to occur between the CMR-2 and CMR-3 locations. This orientation is consistent with one of the air photo lineaments shown in Figure 2 and faults found in Twomile Canyon (Ref. 13). The total displacement of the faulted stratigraphy in the CMR-6 core is approximately 8 feet in the last 1.22 million years.

Based on this investigation, it can be concluded that the CMR Building site has, in the past, been impacted by fault rupture. However, as discussed later in this report, the probability of an earthquake causing significant surface displacement at this site in the future is small.

The discovery of a fault under the CMR Building has an impact on decisions concerning upgrades and future uses for the facility. From the seismic perspective, the question which needs to be assessed is whether or not it is prudent to upgrade the structure to resist ground motion loads when the probability of damaging surface rupture is near the performance goal level for the facility. While it is possible to upgrade to resist the displacements caused by permanent ground deformation, the upgrade costs would increase substantially. It should be noted that this site would not be considered adequate for a new nuclear facility.

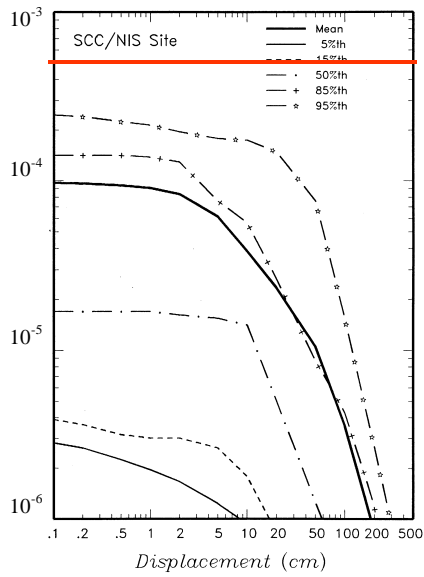
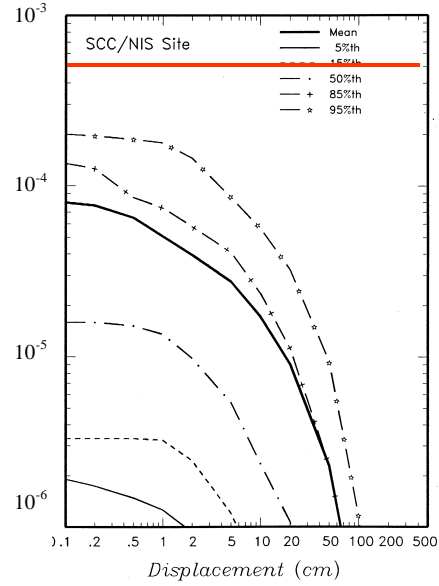
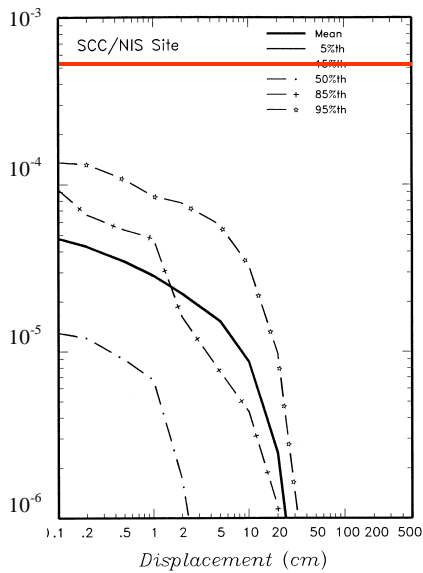
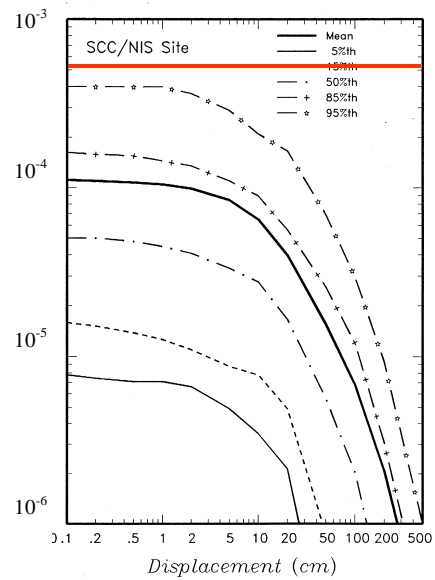
Figure 4 – Surface Rupture Hazard Curves for the SCC/NISC Site (Performance Goal for Performance Category (PC) 2 Facilities is 5×10^{-4})

The results, summarized in Table 2, show that for annual frequencies of 10^{-4} or larger, surface rupture is minimal or nonexistent. The hazard curves developed for the two sites are shown in Figures 4 and 5. Hazard curves that investigate the sensitivity of the three main faults being connected or not are shown in Figure 6.

Figure 4a – Case 1a:
Distributed Faulting w/ 9 m
Cumulative Displacement

Figure 4b – Case 1b:
Distributed Faulting w/ 1 m
Cumulative Displacement

Figure 4c – Case 1c:
Distributed Faulting w/ no
Cumulative Displacement

Figure 4d – Case 2:
Principal Faulting w/ 15 m
Cumulative Displacement

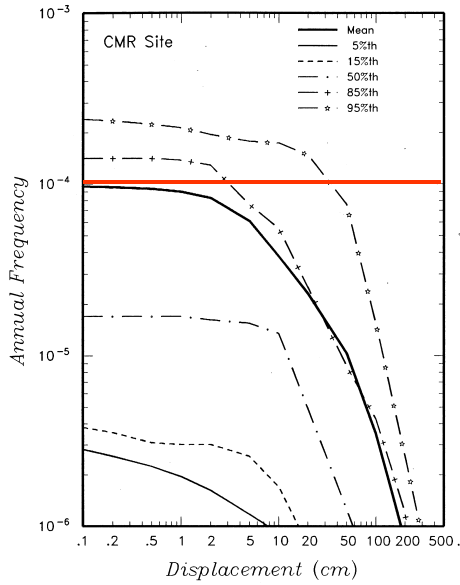
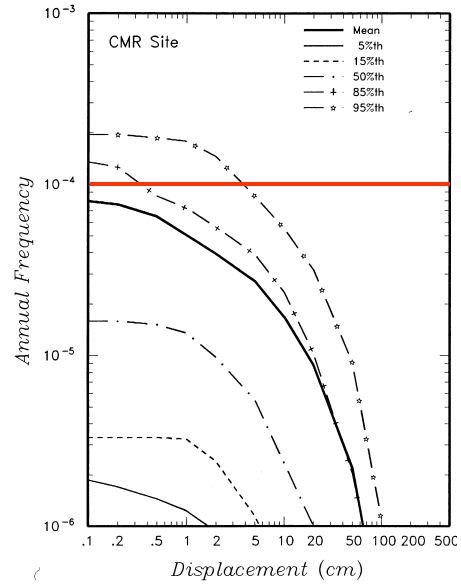
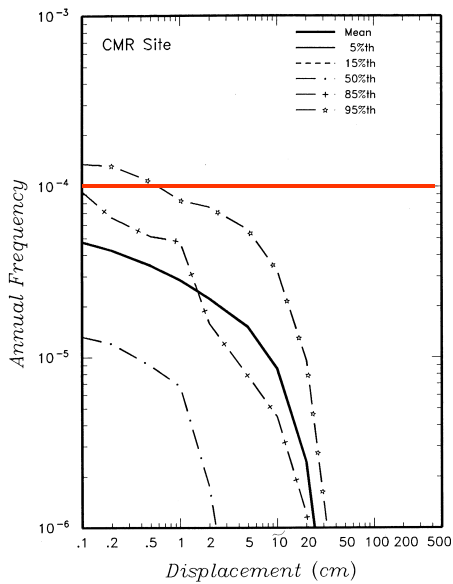
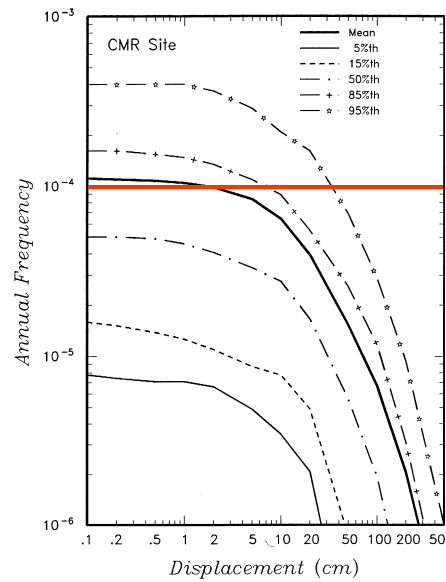
Figure 5 – Surface Rupture Hazard Curves for the CMR Building Site (Performance Goal for Performance Category (PC) 3 Facilities is 1×10^{-4})

Figure 5a - Case 1a:
Distributed Faulting
9 m Cum. Displacement

Figure 5b - Case 1b:
Distributed Faulting
1 m Cum. Displacement

Figure 5c - Case 1c:
Distributed Faulting
No Observable Displacement

Figure 5d - Case 3:
Principal Faulting
15 m Cum. Displacement

The CMR Building is a PC 3 facility that contains special nuclear materials. The performance goal for design basis earthquakes is 1×10^{-4} . The vertical offset of the fault under the facility lies between the existing conditions evaluated in cases 1a (9m offset) and 1b (1m offset) in Reference 6. As shown in Table 2, the probable offset for these cases at the performance goal is less than 1 mm. This small amount of displacement has a negligible effect on structures and it could be concluded that the discovery of this fault is not a credible hazard for the design basis event.

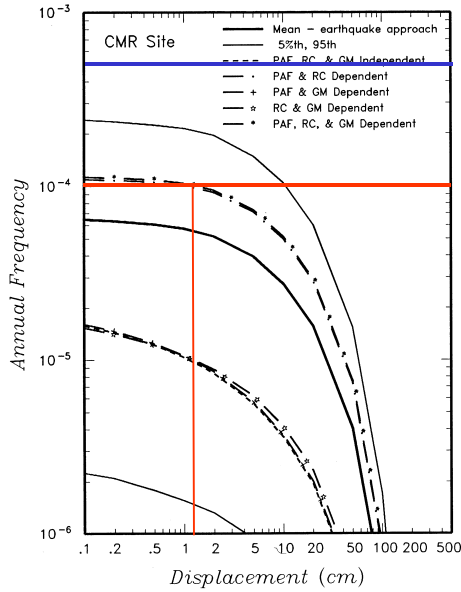
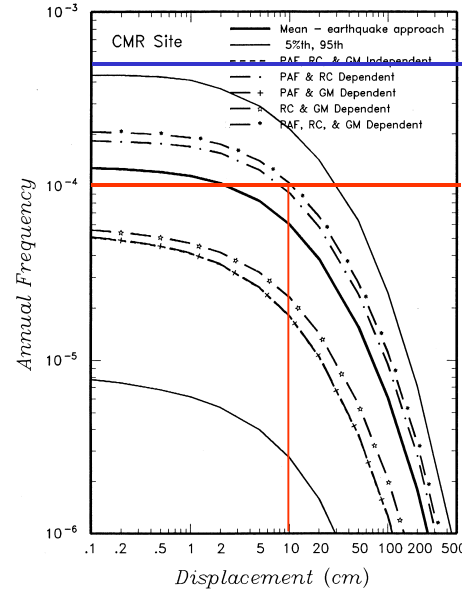
Figure 6 – Surface Rupture Hazard Curve Sensitivity Results (Illustrates the Effects of Assuming Fault Dependency on Hazard Curves.)

Figure 6a – Case 1b Figure 6b – Case 3:
Distributed Faulting w/ 1 m
Cumulative Displacement

Principal Faulting w/ 15 m
Cumulative Displacement

However, if the worse case assumption is made that this is a principal fault and that all three faults are connected, the estimated offset from Figure 6 for the PC 3 performance goal is approximately 10 centimeters (4 inches). A displacement of this magnitude can cause significant cracking in a concrete shear wall structure such as those used in the construction of the CMR Building. This cracking could result in a loss of confinement.

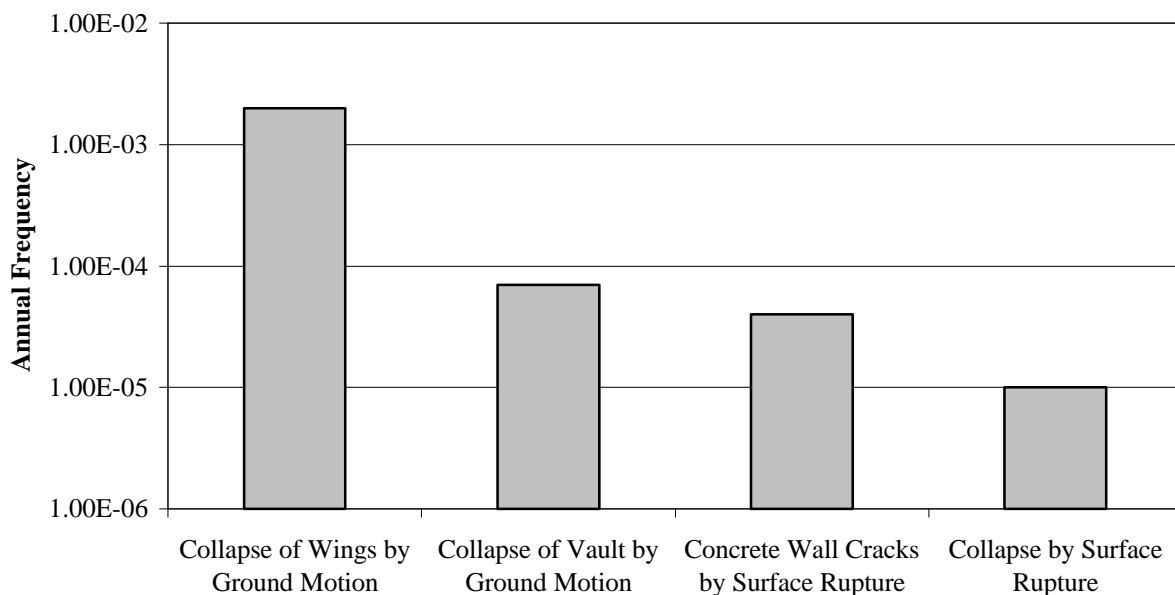
Figure 8 – Frequency of Seismic Induced Damage at CMR Building

It can be shown (Ref. 12) that the annual probability of seismic induced failure, based on ground motion associated with an earthquake, is about 2×10^{-3} for most areas of the CMR Building. The exceptions to this is the vault that has an annual probability of seismic induced failure, again, based on ground motion, of about 7×10^{-5} , and the floor wells which have yet a lower probability of failure. The significance of this information is that ground motion could cause a loss of confinement for most areas of the CMR Building at frequency that is at least 20 times greater than surface rupture.

Based on the information from the referenced studies, the fault under the CMR site is a subsidiary fault. As a result, any movement on the fault is likely to be small and would be a result of a large (Magnitude 6 to 7) earthquake on the Rendija Canyon or the Pajarito fault. Such earthquakes are low probability events. In Figure 8 the estimated annual frequency of damage caused by ground motion is compared to the annual frequency of damage caused by surface rupture. This figure illustrates that damaging surface rupture is far less likely to occur than damaging ground motion.
